EVALUATION OF POLLUTION ABATEMENT PROCEDURES, MORAINE STATE PARK

Gwin, Dobson and Foreman, Incorporated

EPA-R2-73-140
JANUARY 1973

Evaluation of Pollution Abatement Procedures, Moraine State Park

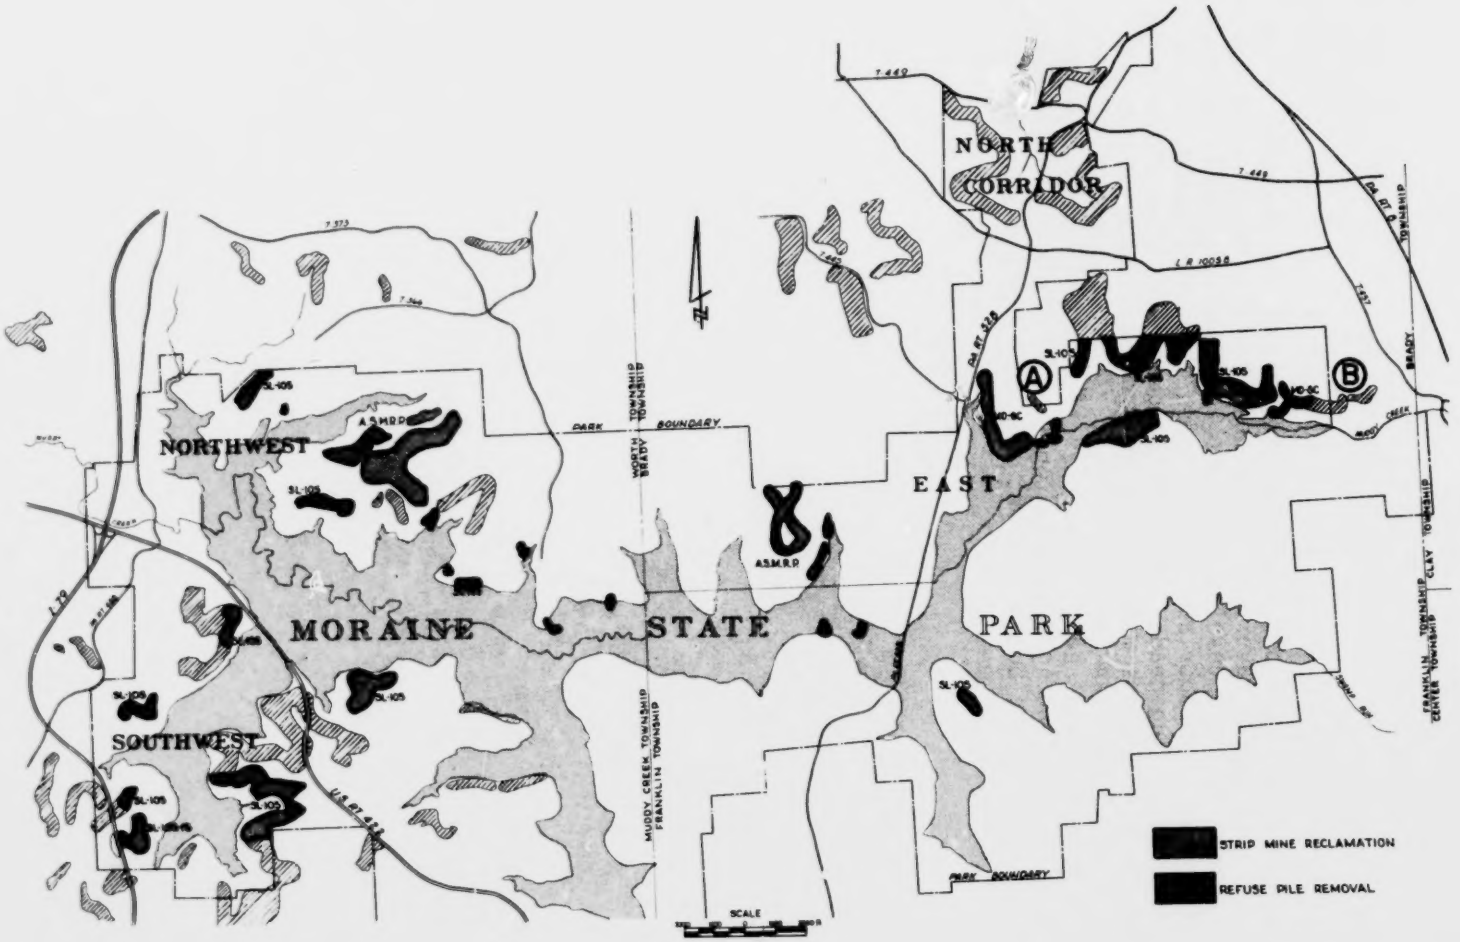
FIGURE 4

1. Backfilling and possibly mine sealing is recommended for the small strip mine located along the park boundary near the Kildoo deep mine (see point A in Figure 4). Similar abatement should also be applied to another strip mine area outside the park boundary in the Muddy Creek watershed (see Point B in Figure 4).

There is remaining a small strip mine area of five acres located partly in and partly out of the park near the Kildoo deep mine which should be included in future reclamation work. There are also about thirty acres outside of the park area but in the Muddy Creek watershed which should be considered in future abatement work.

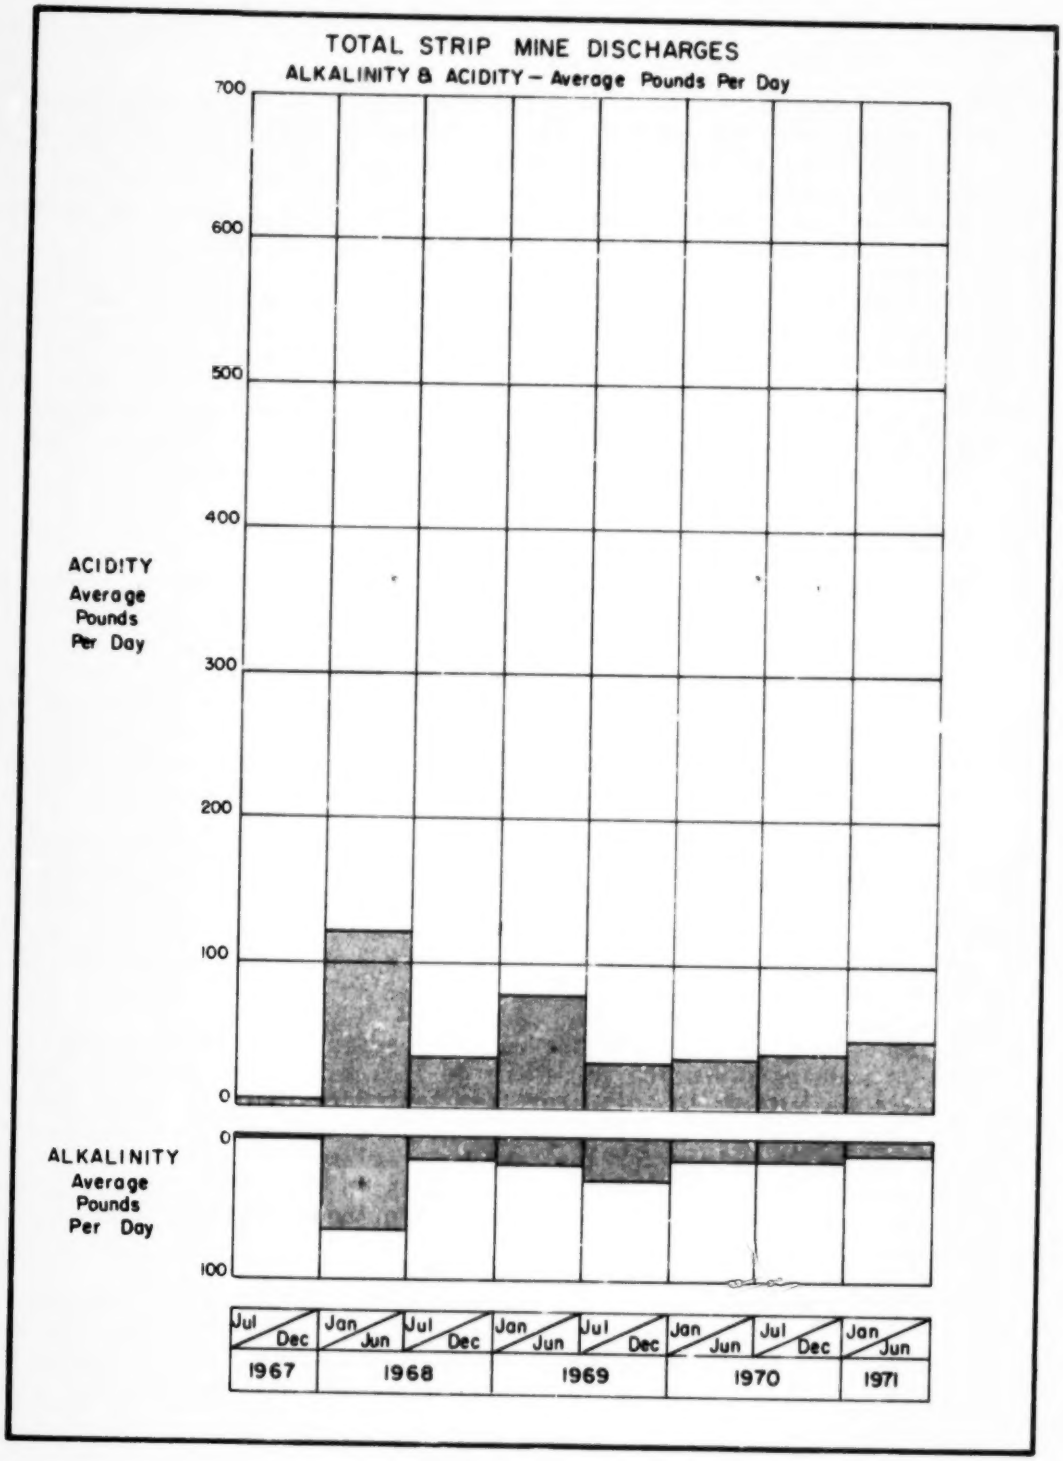
FIGURE 11

The strip mine discharges were far more erratic than the deep mine discharges; however, their contributions have always been less than 21% of the total pollution load. The production of both alkalinity and acidity in the strip mine discharges is directly affected by the climatic conditions, particularly precipitation. The production of acidity from strip mines has ranged from less than 1% of the total acid production during dry periods to 21% during wet periods throughout the four year study. (See Figure 11)

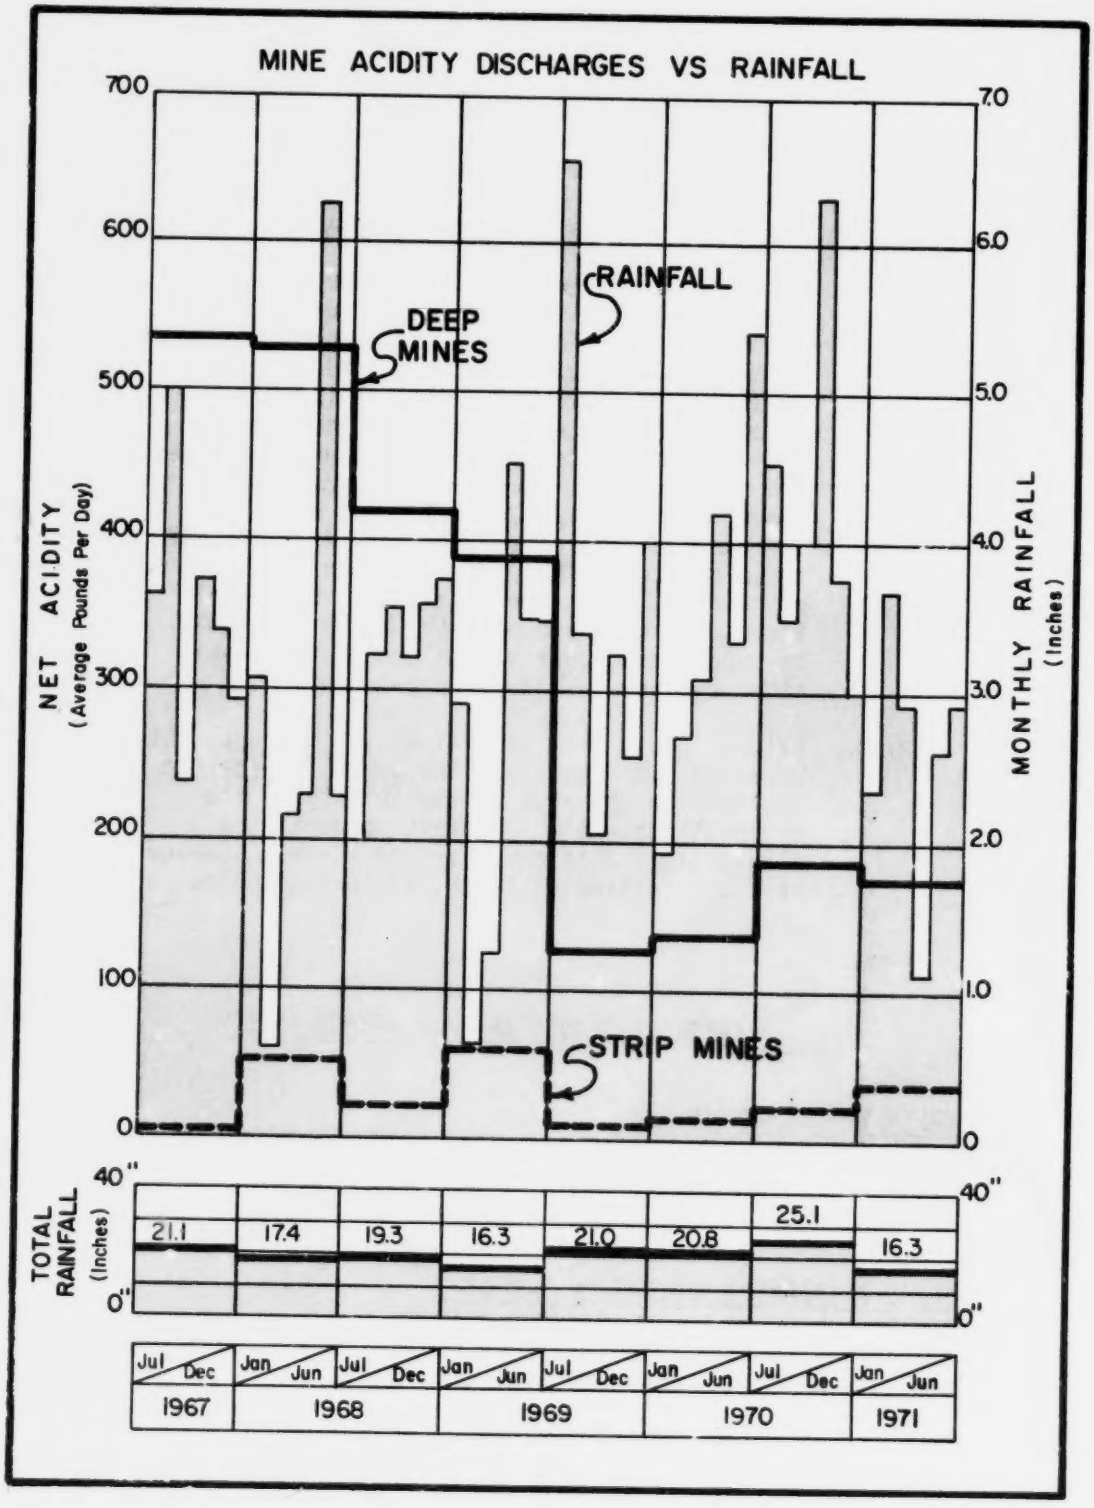
FIGURE 12

1. Rainfall Effect: Figure 12 illustrates the interrelationship of monthly rainfall and average total mine discharges of the two major classes. The greatly diminished discharge acidities for the deep mines follow the rainfall intensity pattern very closely as would normally be expected, since the mine "make" water in the unsealed sections should be proportional to total rainfall. However, the total amounts of acid being generated remain at a low level (less than 200 ppd) even during periods of excessive rainfall (July to Dec. 1970). The reclaimed strip mine areas do not show any direct correlation to rainfall intensity, primarily because the sampling of these areas was not timed to correspond to periods of rainfall. The obvious (but unquantified) effect of abatement treatment was the diversion of large volumes of surface run-off from these sites, thus greatly reducing the magnitude of acid slugs normally produced. The graph does show very clearly,

however, that after abatement treatment, acid generation in these areas remains very small and undergoes very little change under varying conditions of atmospheric precipitation. This demonstrates the establishment of a significant degree of pollutant generation control.
